November 26, 2020

**Re: Soil Survey and Canada Land Inventory (CLI) Assessment
Nelson Aggregate – Burlington Quarry West Extension
Part Lots 1 and 2
Concession 2 (Former Nelson Township)
City of Burlington
Region of Halton**

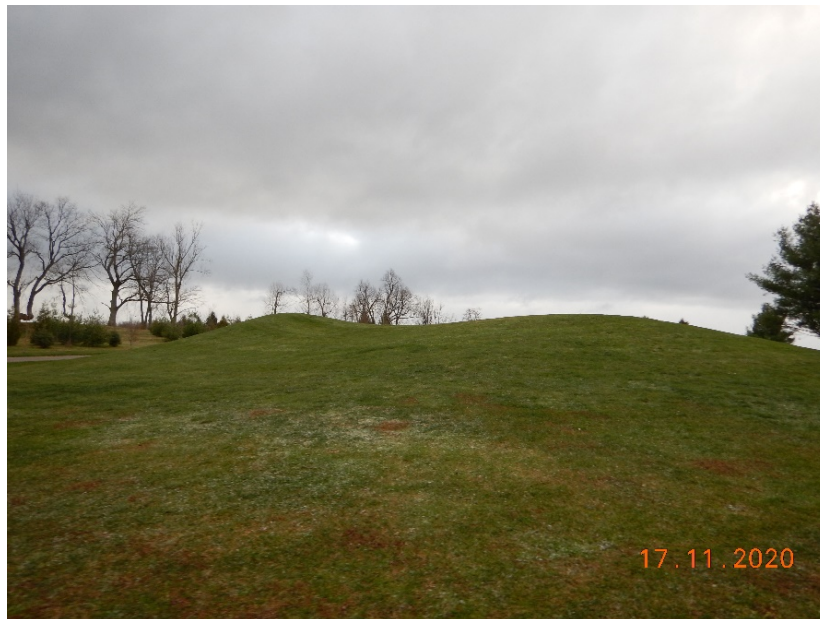
Photograph of landformed hills adjacent to the fairways.

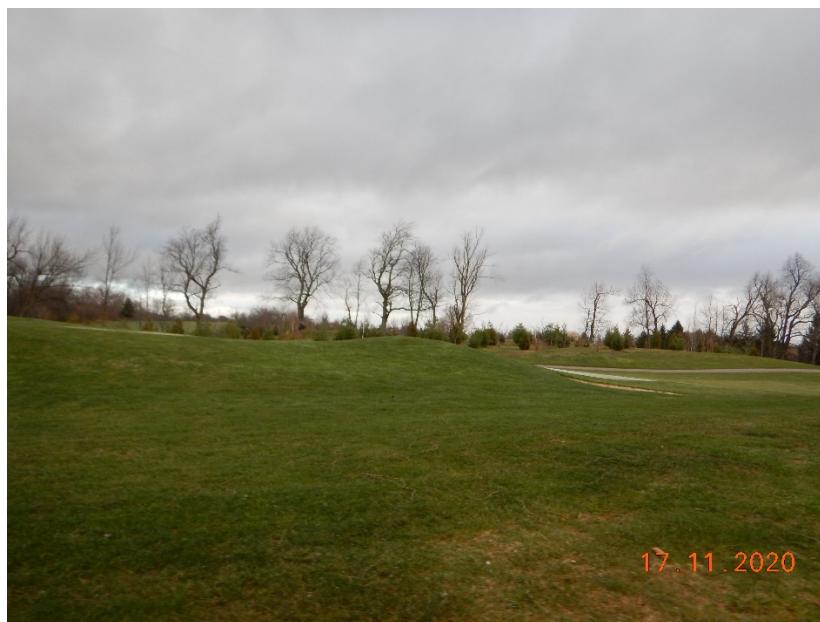
Photograph of landformed hills along fairways.

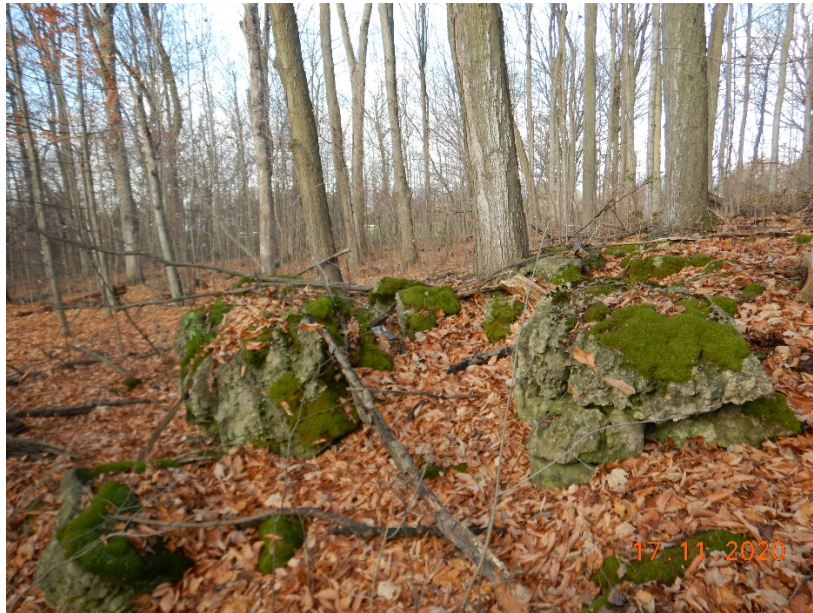
Photograph of large area of bedrock outcrop.
